SUDBURY RIVER BASIN  
FRAMINGHAM, MASSACHUSETTS

CENTRAL STREET DAM  
MA 00340

PHASE I INSPECTION REPORT  
NATIONAL DAM INSPECTION PROGRAM

FEBRUARY 1980

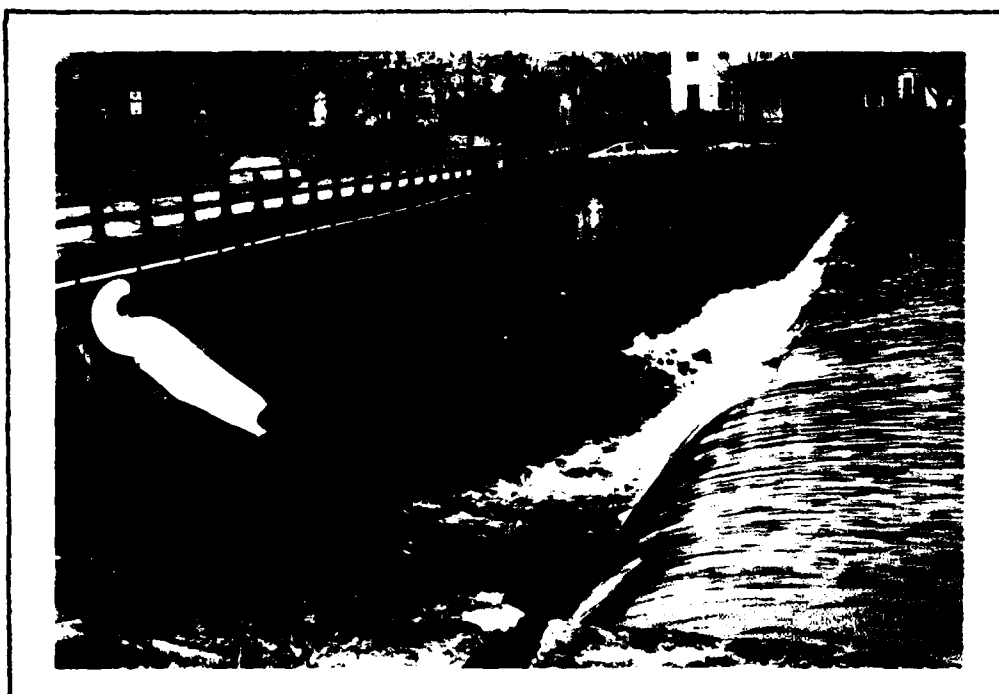
DOWNSTREAM OVERVIEW OF THE DAM FROM THE LEFT SIDE SPILLWAY  
ABUTMENT. (11/12/79)

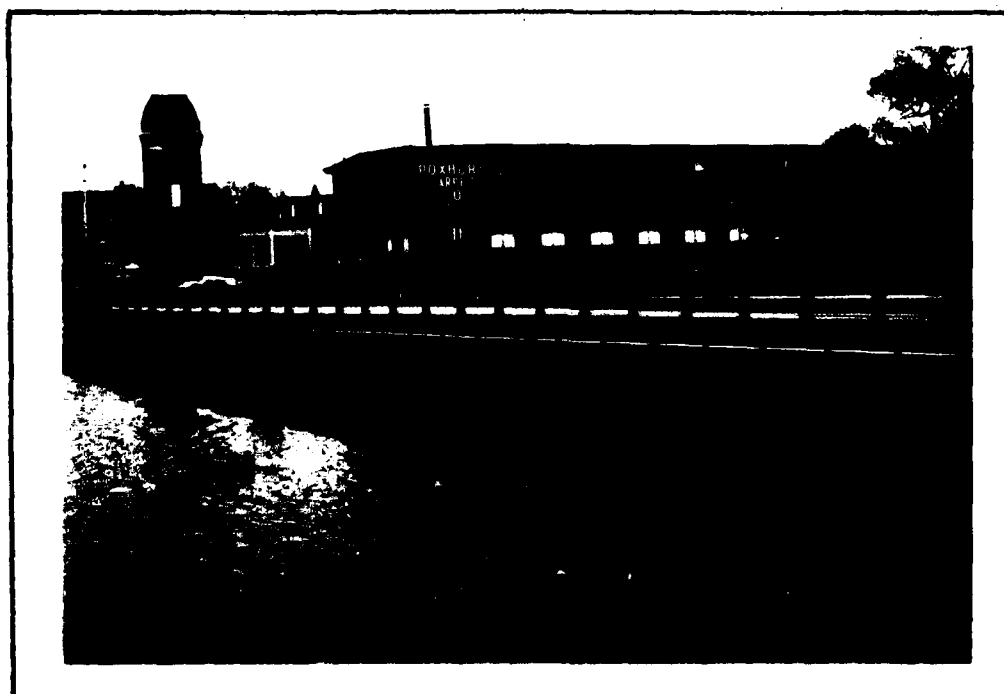
2. LOOKING ACROSS THE SPILLWAY FROM THE RIGHT SIDE SPILLWAY ABUTMENT SHOWING CONDITIONS IMMEDIATELY DOWNSTREAM OF THE DAM. (11/12/79)

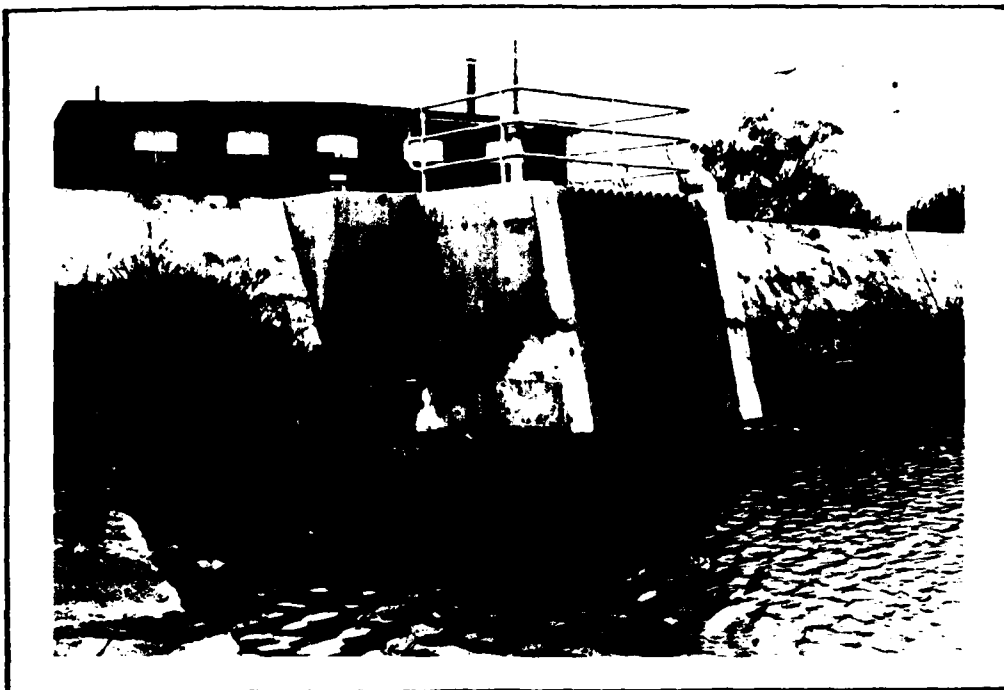
5. INLET DETAILS FOR THE 4-FOOT WIDE BY 6-FOOT HIGH IMPOUNDMENT REGULATING GATE APPROXIMATELY 110 FEET LEFT OF THE LEFT SIDE SPILLWAY ABUTMENT. (11/12/79)
